TECHNICAL MEMORANDUM

DATE: February 14, 2024 Project No.: 1088-60-23-02

SUBJECT: Graton Community Services District
Sanitary Sewer System Condition Assessment Technical Memorandum – Draft

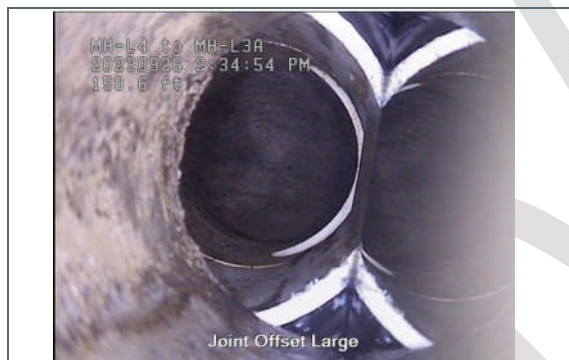
Photo 1.
 Offset Joint - Large (camera rotated 90° clockwise)

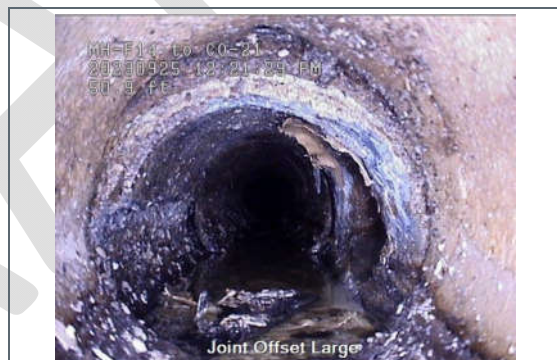
Photo 2.
 Offset Joint - Large

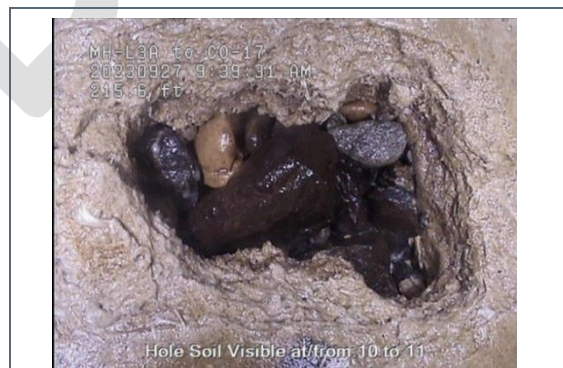
Photo 3.
 Hole/Broken with Voids Visible

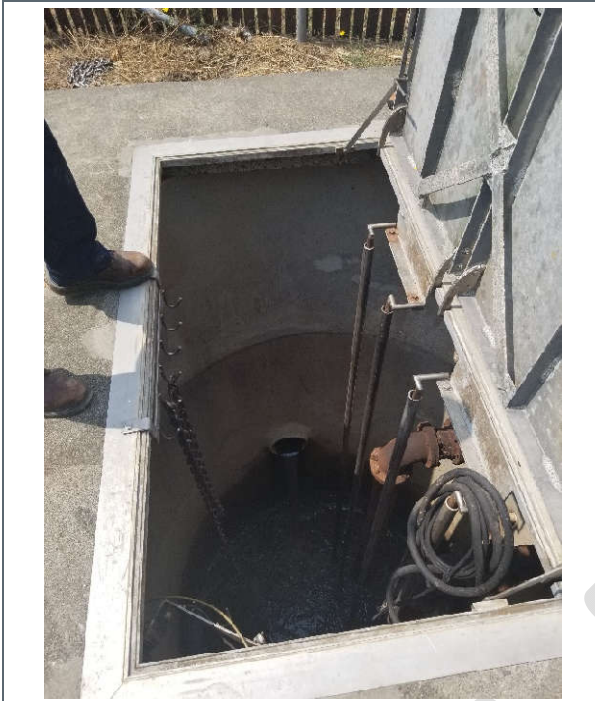
Photo 1
Lift Station 1 Wet Well

Discharge piping in wet well	4	3	Corrosion along entire section. See Photo 1 below.	Replace
Water Service Well	3	1	Well on site, shared ownership with neighbor	None
Valve Vault	2	1	Concrete and grates in good condition; minor build up of sediment/debris in bottom of vault.	None
6-inch Plug Valve (x2)	3	1	Minor corrosion on valve body and major corrosion on bolts. Functionality of valves is unknown; due to potential risk of damaging valves and age, recommend to replace valves.	Replace
6-inch Check Valve (x2)	3	1	Minor corrosion on valve body and major corrosion on bolts. Due to age, recommend to replace valves.	Replace
Hoist	2	3	Rust on bolts, otherwise in good condition. Portable hoist is unstable.	Consider installing more robust and permanent hoist.
Generator	4	3	Existing generator is not efficient and is obsolete; no parts available for repair and finding someone capable of work is difficult. See Photo 2 below.	Replace

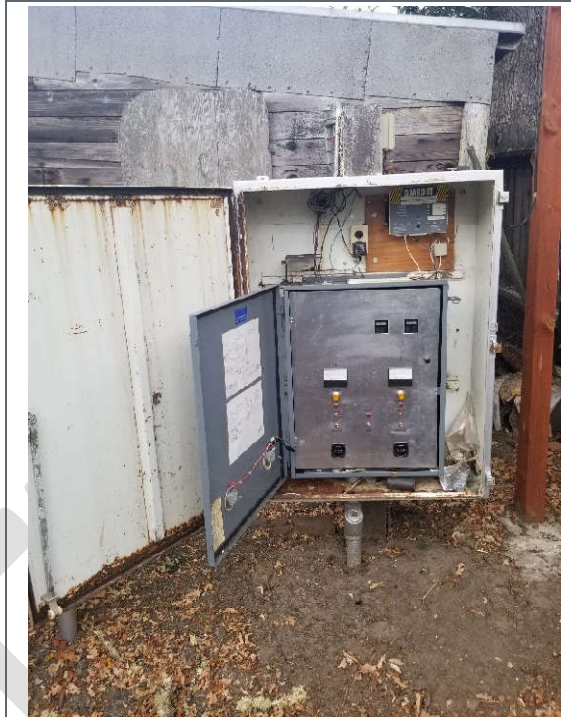
Photo 5
Lift Station 2 Cabinet

Security	1	1	Lock on electrical/control box	None
Meter/Control Housing	3	2	Corrosion along inside seals and bottom of box. See Photo 5 below.	None
Meter/Control Cabinet	1	1	In good shape, seals are good and no signs of corrosion. See Photo 5 below.	None
Electrical & Instrumentation/Controls	3	2	Seals on inner panel appear intact and components in acceptable condition. Outer enclosure is in corroded at bottom, potentially due to poor conduit seal from wet well instrumentation. See Photo 5 below. Due to apparent age and modifications, all electrical, instrumentation, and controls assets/systems should be replaced.	Replace. Evaluate conduit and seals from wet well to panel for leakage before re-using.
