SUBJECT: OPERATION REPORT: June, 2023

GRATON COMMUNITY SERVICES DISTRICT

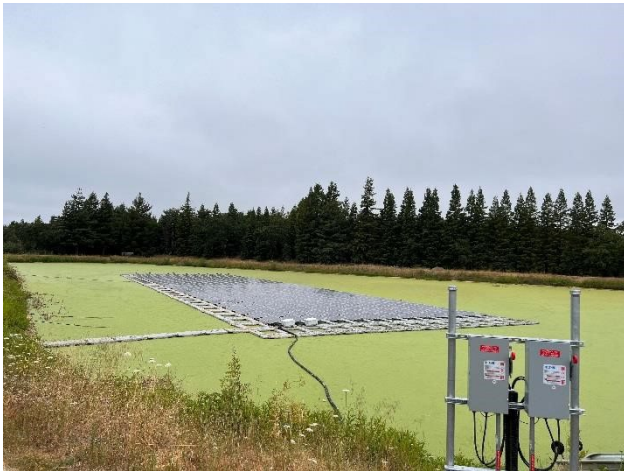
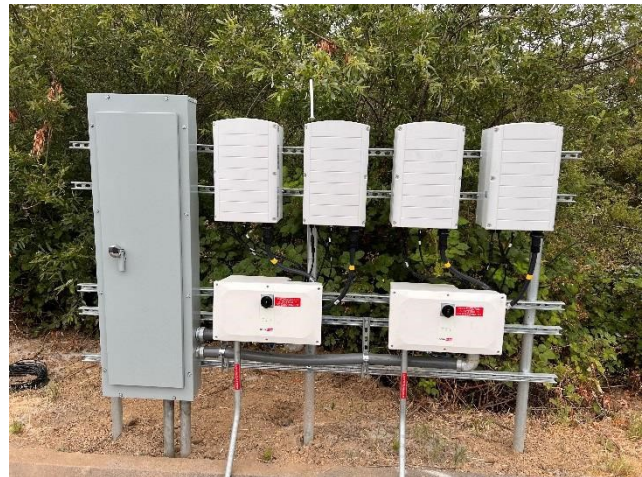
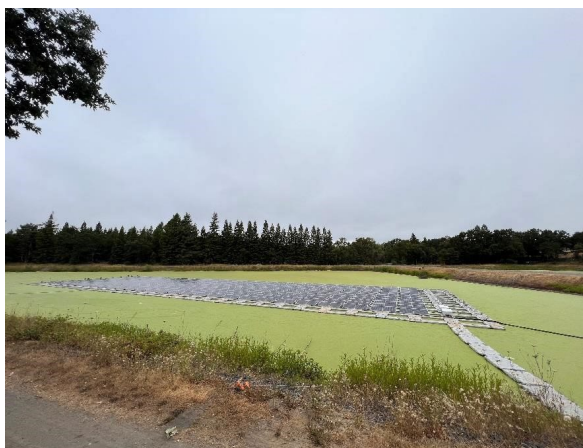
The installation of the floating solar panels in the West holding pond has been completed successfully, and they are now fully operational.
