DATE: December 13th, 2023
TO: Members of the Board of Directors
FROM: John Gibson, Chief Plant Operator
SUBJECT: OPERATION REPORT: November, 2023

Operations Report: Operations, Process Control, and Preventative Maintenance

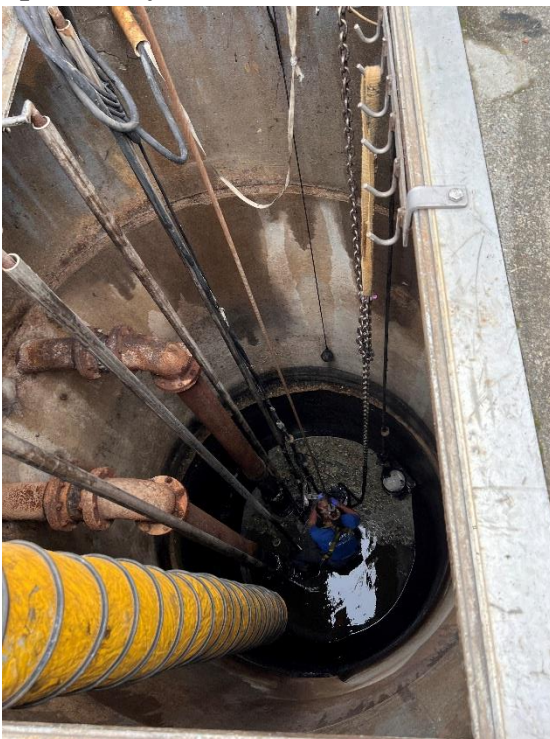
During a maintenance procedure on the lift station pump on November 22nd, a failure occurred with the pump handle, causing the release of the chain used for pulling the pump. PumpMan was called out to perform a confined space entry, reestablish the connection to the pump, and lift it for servicing.

After several attempts, it was determined that the pump was stuck in the wet well but still operational. The decision was made to wait for the arrival and installation of a new Ebara pump to ensure a backup system in case of any complications during removal.

Confined space entry into wet well.

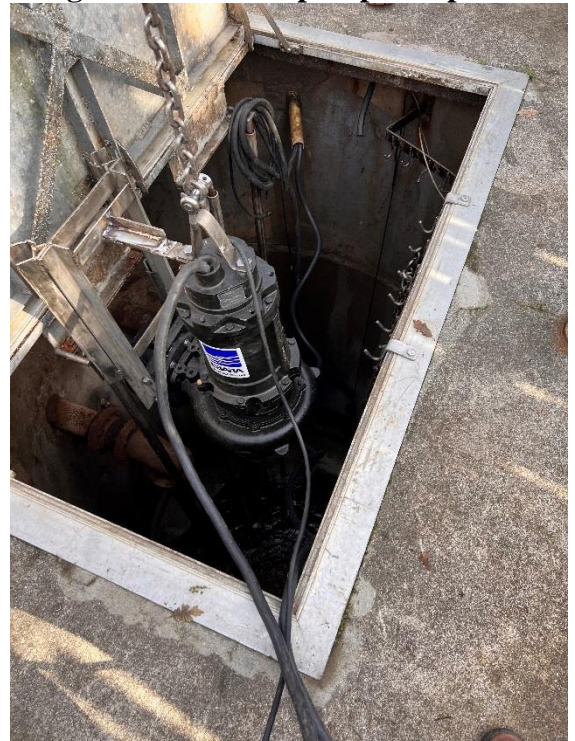
On December 5th Pumpman returned with the new pump assembly and installed checking for proper rotation and operation. The wet well was pumped down and PumpMan technicians were able to connect and free the stuck pump. After de-ragging and inspection, the volute was found to be in need of replacement which was then exchanged with the old Ebara pump. A new stainless-steel handle was installed and the pump placed back into service. During the process, Rick, one of the PumpMan technicians, recommended prioritizing the replacement of the other lift pump, considering its end-of-life status and the impracticality of a rebuild.

Another identified issue was that both pumps did not fully seat, allowing for some bypass around the flange faces. Despite this, both pumps are operational and effectively pumping down the wet well. Wear shoes at the bottom of the wet well, responsible for seating the flanges against the pumps, were noted as potentially requiring replacement. PumpMan will review their records for information on the wear shoes and will provide a quote for replacement, along with alternative options.

Lowering the new Ebara pump into position.
